# Conservation, Augmentation & Preservation of Water Bodies in Ayodhya

# Water bodies management

**108 water bodies have been identified in Ayodhya for water rejuvenation.**

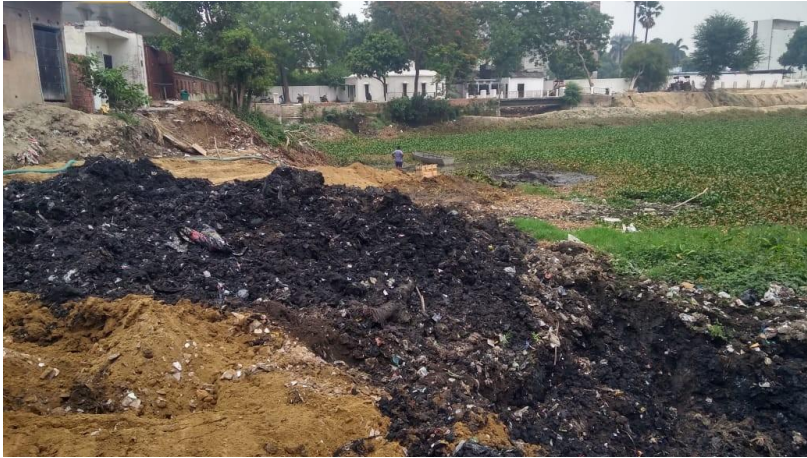
**15-20ft of sludge in existing waterbodies**

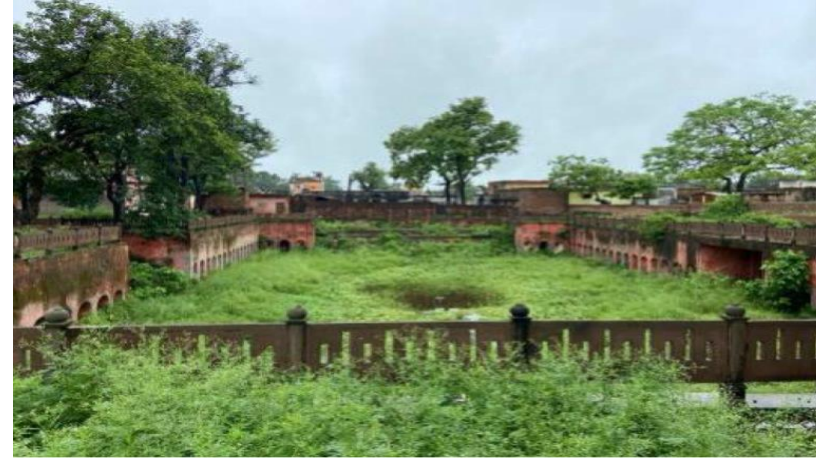
**Waterbodies left unattended since years**

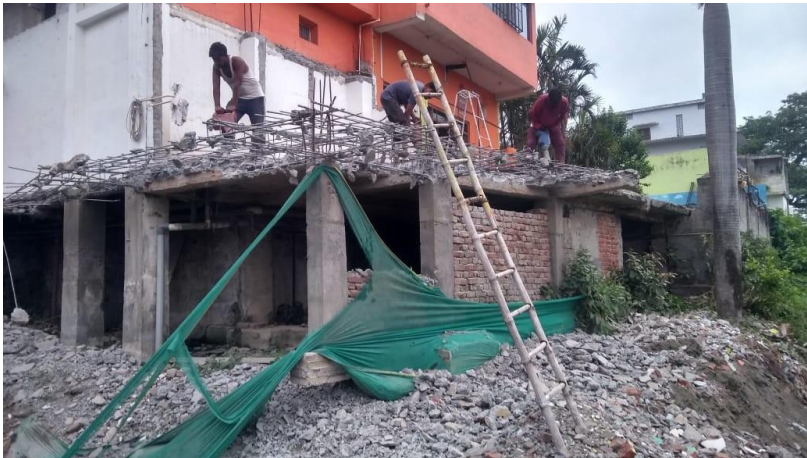
**Encroachment**

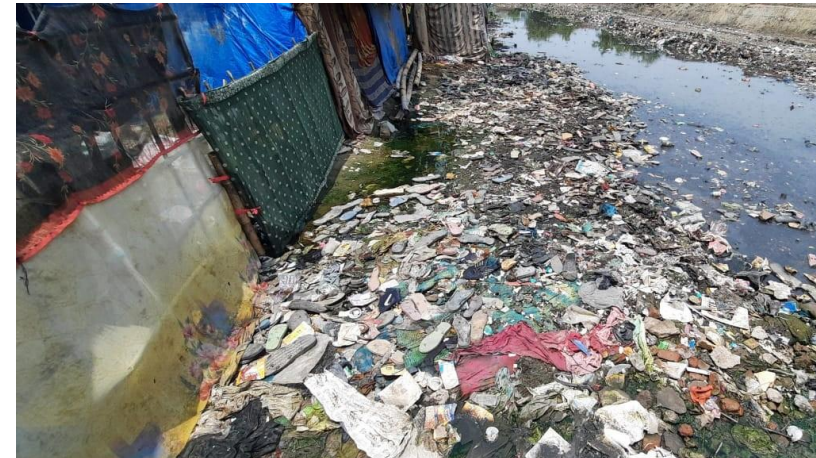
**Sites overflowing with waste specially Chappals**

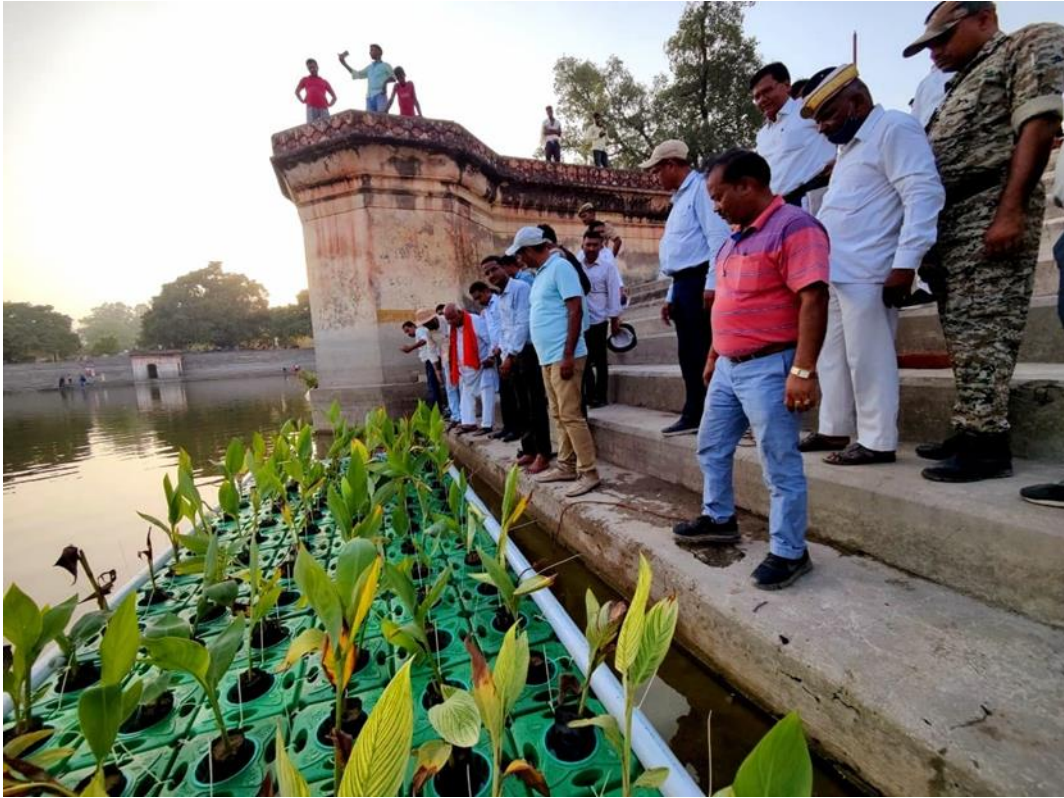
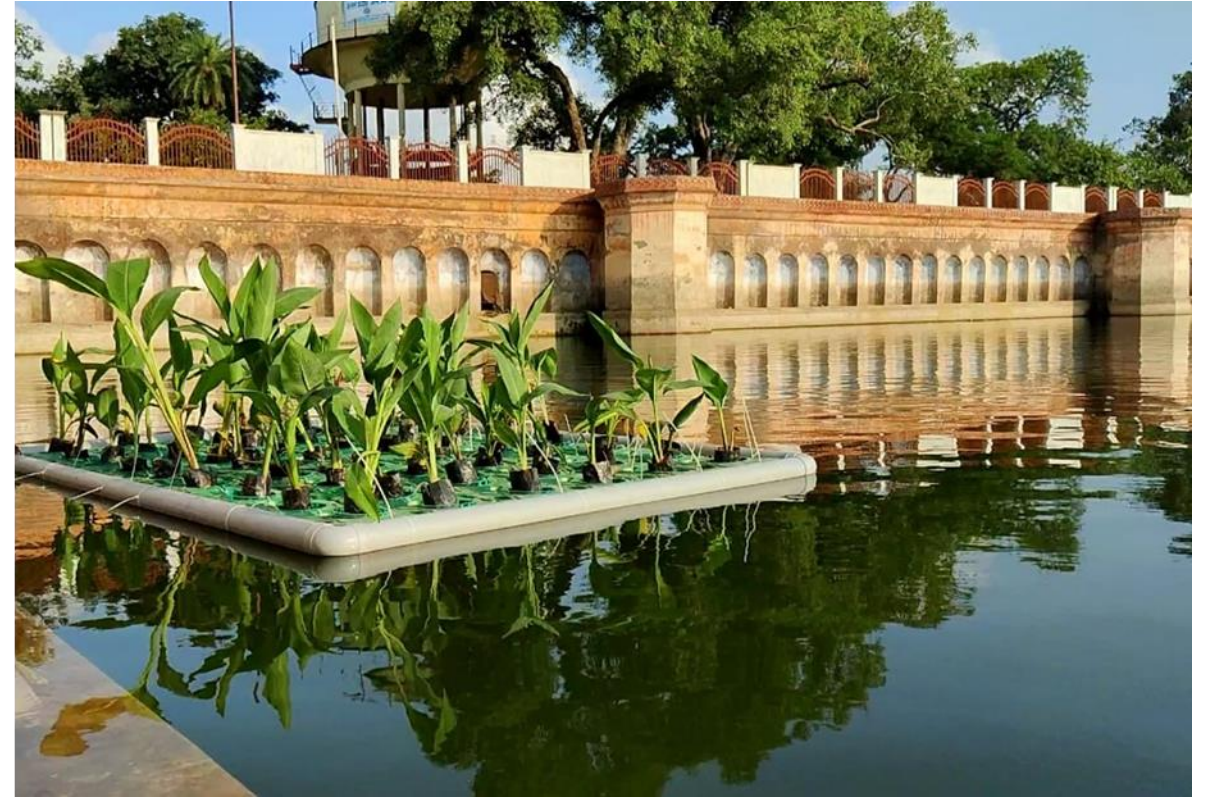
**Floating wetlands at Suryakund to absorb impurities and utilise in growth of plants**
